## Chapter 2 | Existing Conditions

### 2.1 Introduction

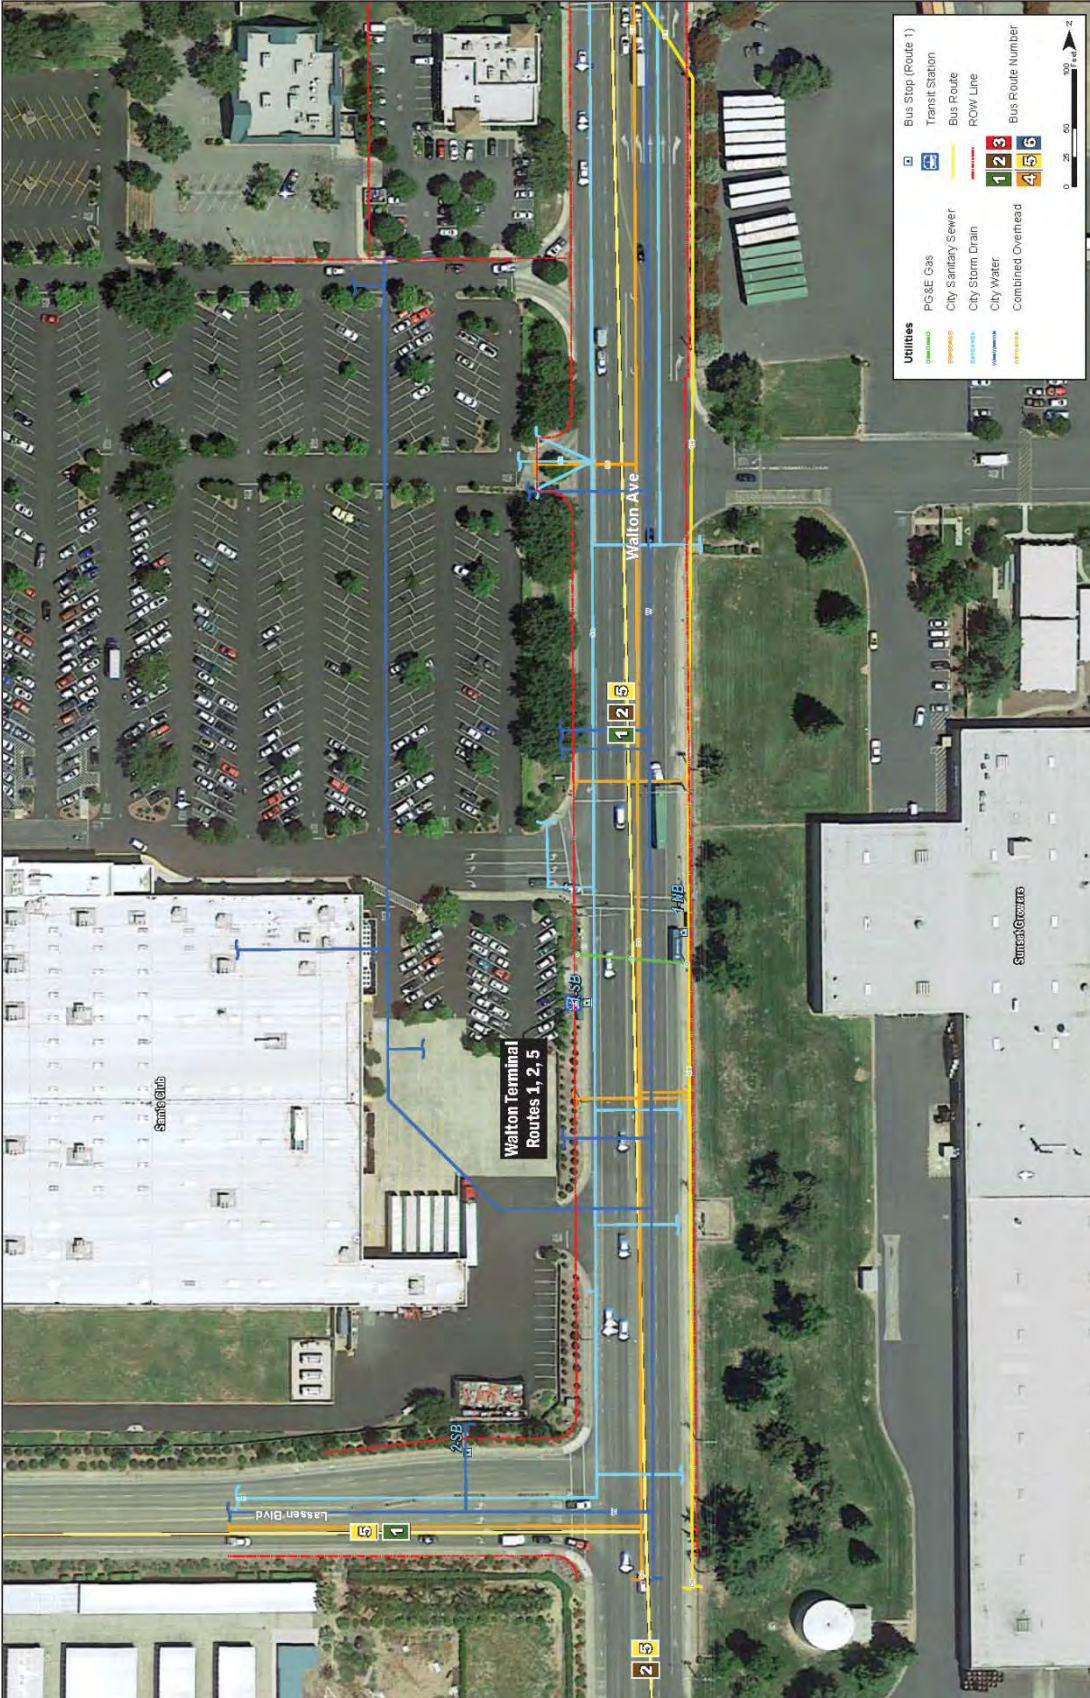
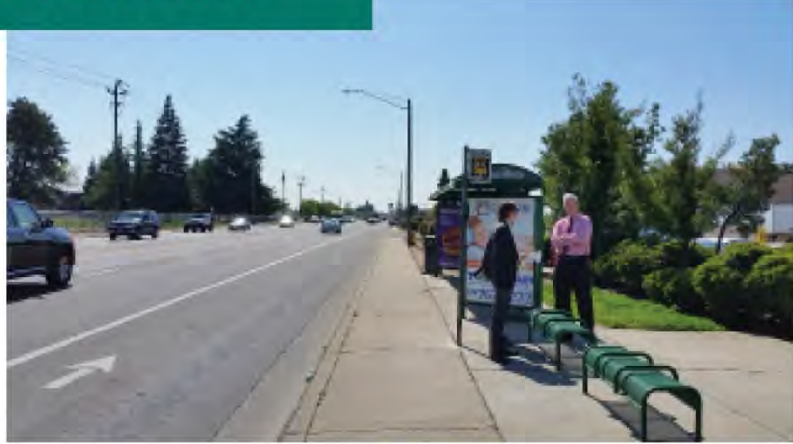
Figure 2.8: Walton Terminal Project Site

Walton Terminal is located on Walton Avenue midblock between the intersection of Colusa Highway and Lassen Boulevard, as shown in Figure 2.8. Figure 2.8 also shows the right-of-way and parcel boundaries and the location of utilities. It is immediately south of the signalized intersection of Walton Ave and the eastern Sam's Club Driveway access. The east side of Walton Ave borders the Sunsweet plant. Walton Ave at this location has four through lanes with a northbound left turn lane, giving it a 5-lane cross section. Two large bike lanes also exist at this location for a total pavement width of approximately 80 feet. The speed limit on Walton Ave at this location is 45 mph.

Walton Terminal is located on Walton Ave midblock between the intersection of Colusa Highway and Lassen Boulevard. It is immediately south of the signalized intersection of Walton Ave and the eastern Sam's Club Driveway access.

The terminal is furnished with two ad shelters with angled ad boards. Each shelter contains one 3-seat bench. Two additional 3-seat benches are located to the north of the ad shelters. The ad shelters are constructed with perforated metal. The rear of the shelters has been modified with plexiglass panels to protect transit riders from wind and rain. A small trash receptacle is affixed to each ad shelter. A large free standing trash bin has been supplied by Yuba-Sutter Transit at this location. Behind the shelters is a large concrete pad which once housed bicycle lockers. These were damaged by vandals and have been removed.

Though the shelter provides very little shade, several small trees are nearby. A northbound stop is located on the opposite side of the street, which is serviced by Route 2A, as well as commuter buses returning from Sacramento. Though there is a protected crossing at the signal crosswalk, passengers have reportedly jaywalked directly between buses, a potential hazard.

No lights are provided by the shelter itself. The light emitting diode (LED) street lights nearby provide very little light. The Sam's Club parking light has bright conventional vapor bulb lights that provide the terminal with light. The high traffic volume along Walton Ave makes this terminal feel relatively safe at night.

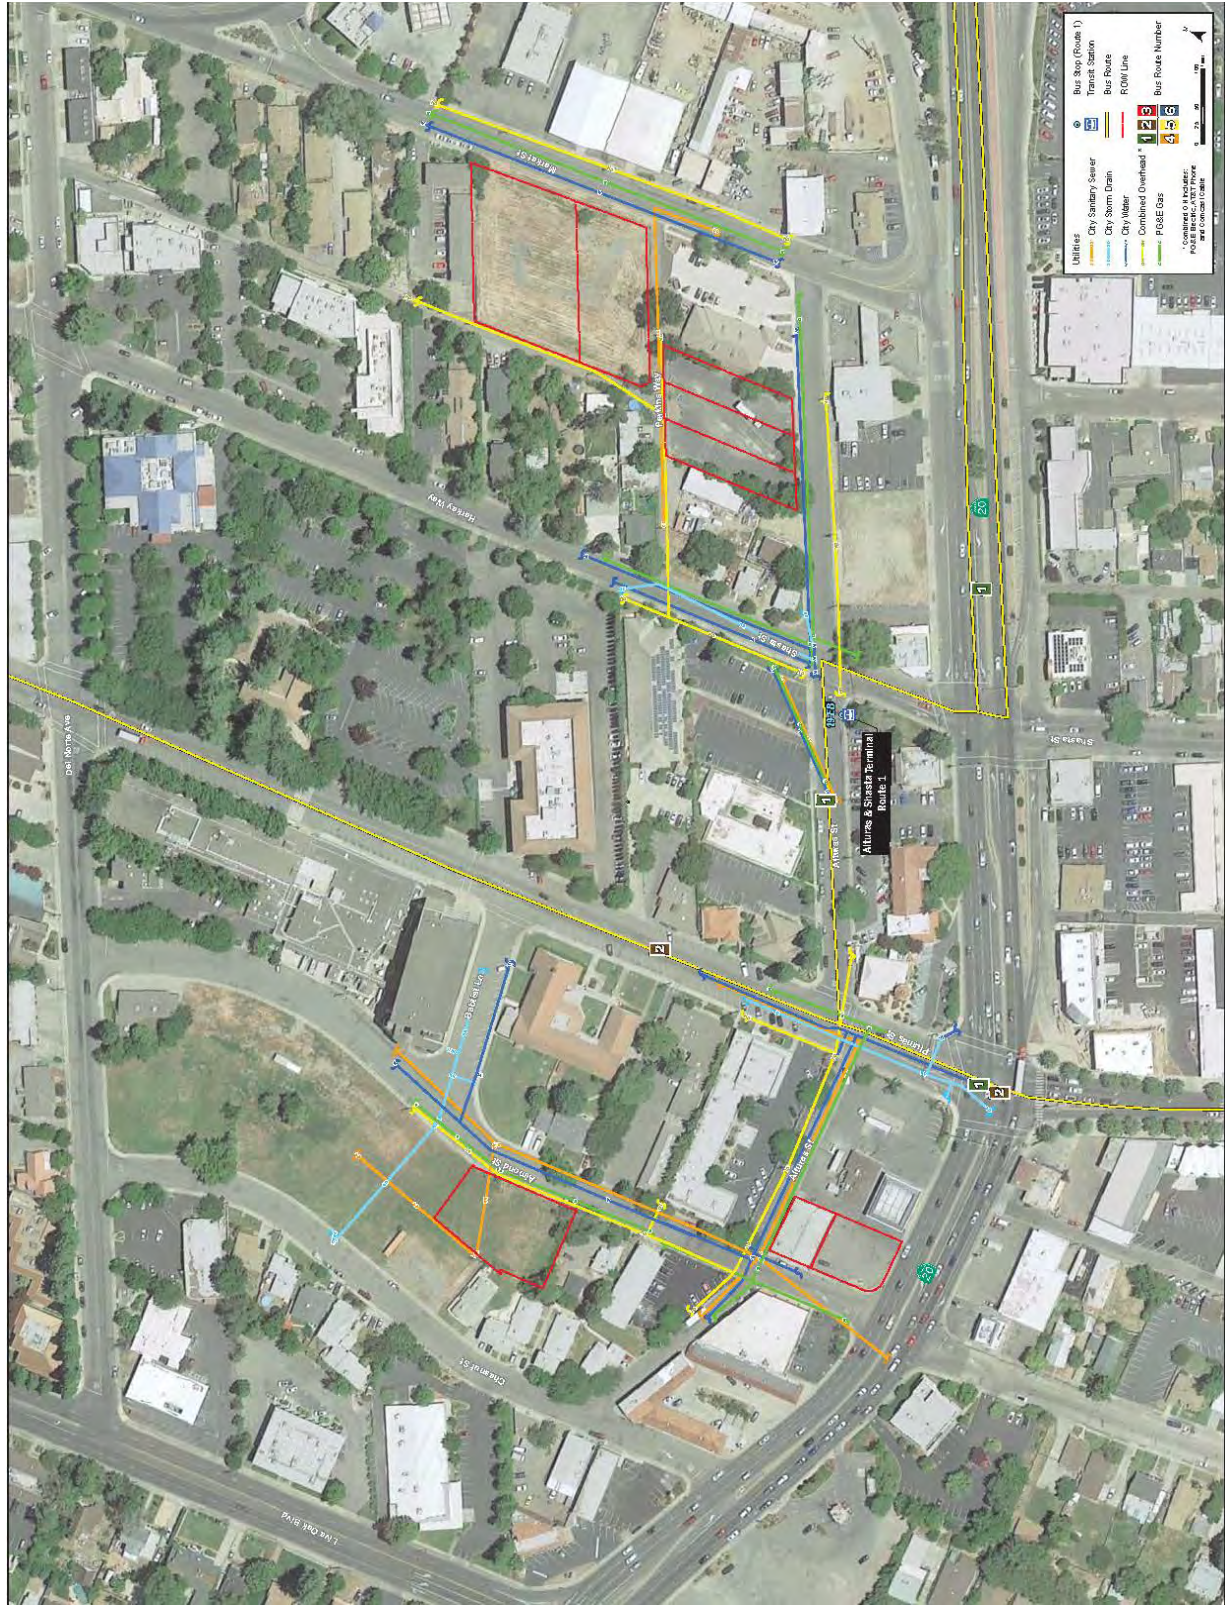
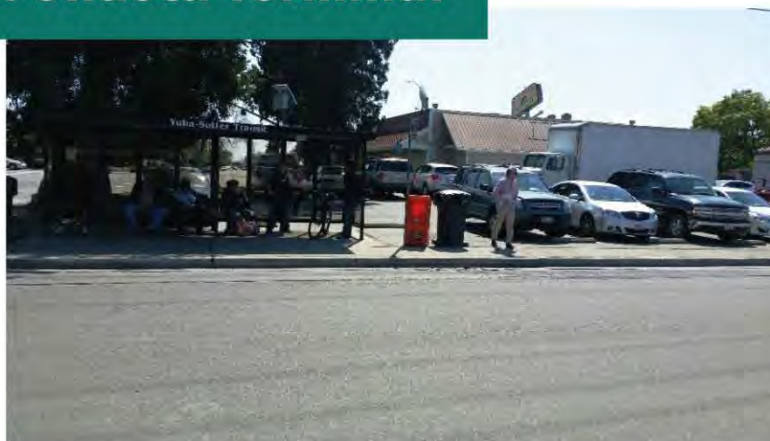
Figure 2.10: Alturas & Shasta Terminal Project Site

A single large Yuba-Sutter Transit owned glass enclosed shelter is provided on the south side of the street. The bus shelter itself resides on the private property of the Taqueria. The shelter has low level solar lighting, benches, and two free standing trash receptacles nearby. A large tree provides adequate shade. The pavement in front of the bus stop consist of, asphalt paving and a concrete gutter. The gutter has sustained damage from the buses. Both eastbound and westbound bus stop activity occurs at this stop. Alturas Street is approximately 38 feet in width, with parallel parking on the north side and the bus loading area on the south. Allocating 8 feet for the parking area and 12 feet for the bus loading area, only 18 feet of pavement is available for two-way traffic movements. Eastbound vehicles approaching the parked bus often drive around the bus encroaching into the opposing (westbound) travel path. A northbound left turning vehicle was observed narrowly avoiding colliding with an eastbound vehicle that was pulling around the bus. Due to the position of the parked bus the northbound left turning driver was not able to see the advancing hazard.

Due to the variation in route travel times, there are frequently two buses (and sometimes three) present at this location. It is difficult for the third bus to fully pull parallel to the curb (thereby creating a potential tripping hazard), and the third bus can block the adjacent parking lot driveway.

The low level shelter lights provide little to no useful light. Between the nearby street light and flood light provided by the restaurant, the terminal has an adequate lighting level. However, the shelter faces north towards an empty (in the evening) parking lot. If not for the activity at the rear of the restaurant this terminal location would feel very unsafe during low light conditions.

The Alturas and Shasta terminal is located immediate west of the intersection of Alturas Street and Shasta Street. It is situated at the back corner of the Los Charros Taqueria parking lot.

- Narrow sidewalk adjacent to bus loading area
- No protected pedestrian crossing across Alturas Street

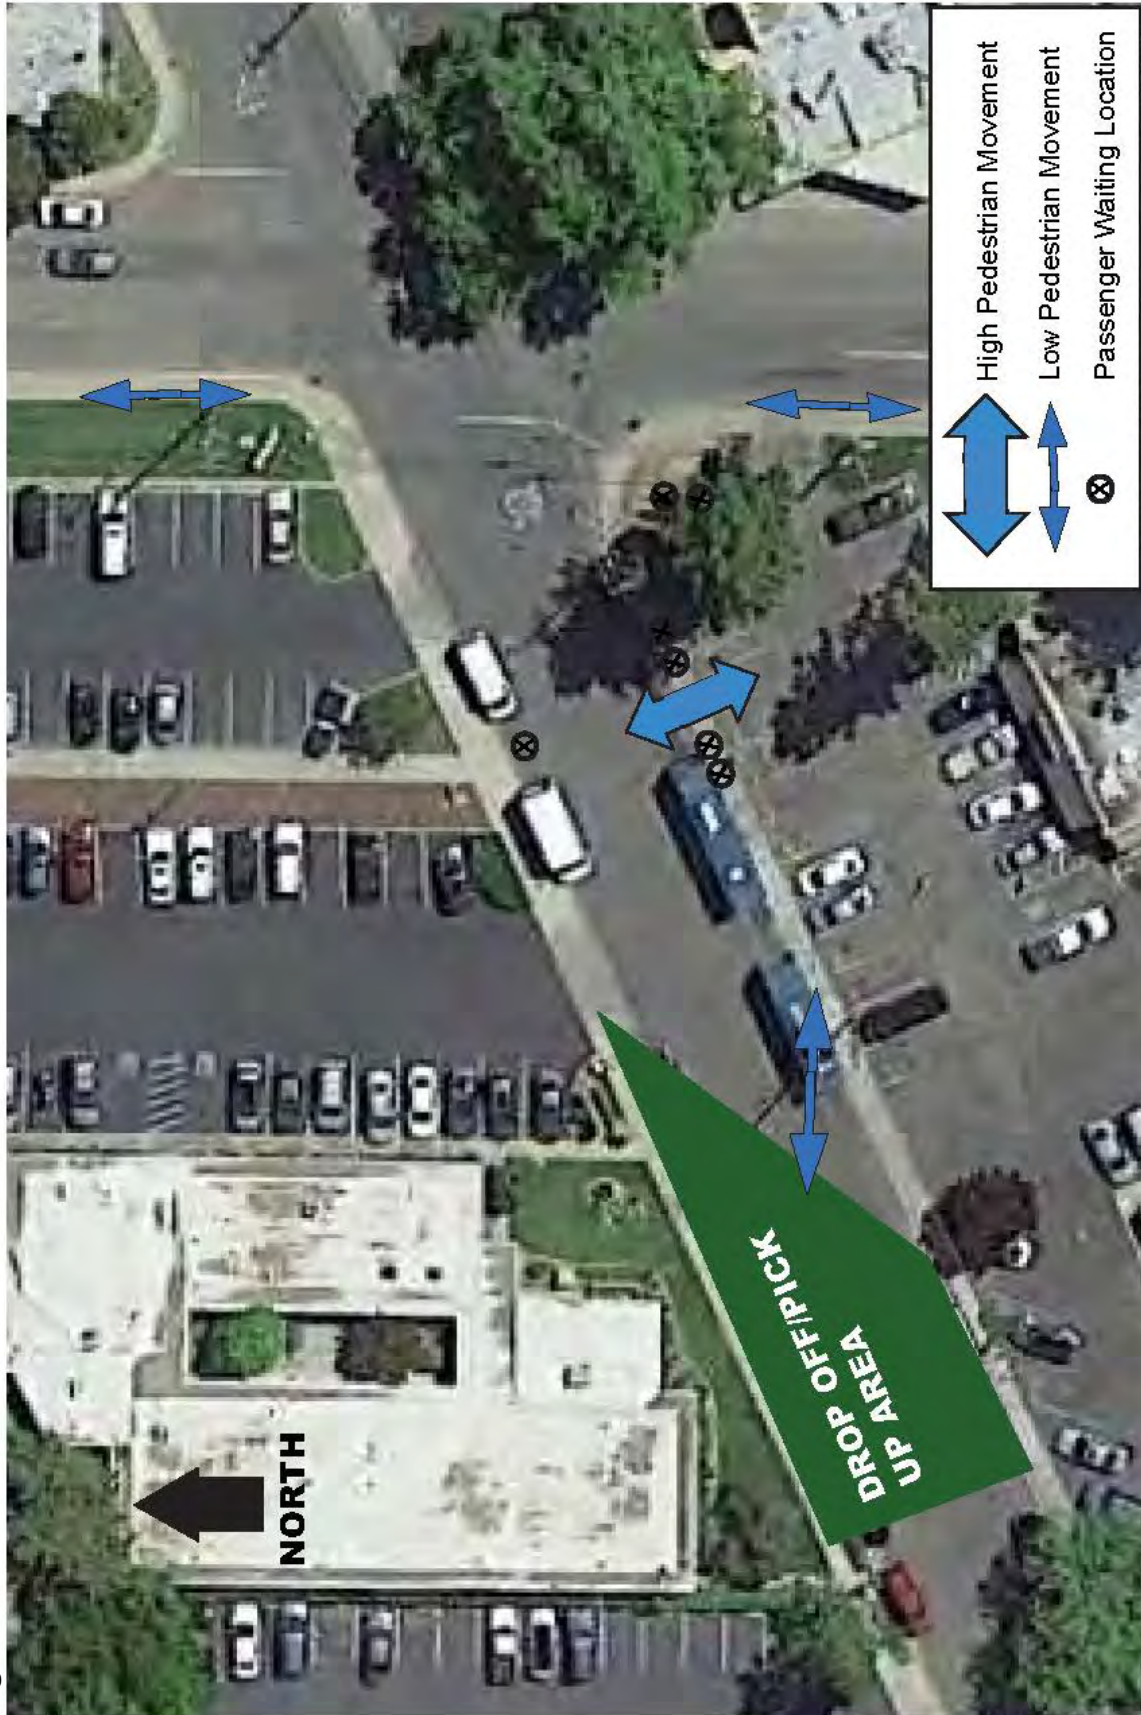
Figure 2.1 I: Alturas & Shasta Terminal Access

A summary of passenger movement and activity at the Alturas & Shasta Terminal is illustrated in Figure 2.11. The volume of transit riders often overwhelms the shelter resulting in riders waiting under the nearby tree or within the restaurant parking lot. No transit passengers were observed to sit on any of the cars parked within the Taqueria's lot. Generally, passengers sat on the benches within the shelter or leaned on the outside shelter. One passenger was observed sitting on the curb across the street and ran over when the bus approached. The majority of the passengers were transfers (80%). Approximately 10% walked to the terminal from the nearby residential neighborhood. The remaining 10% were either picked up or dropped off.

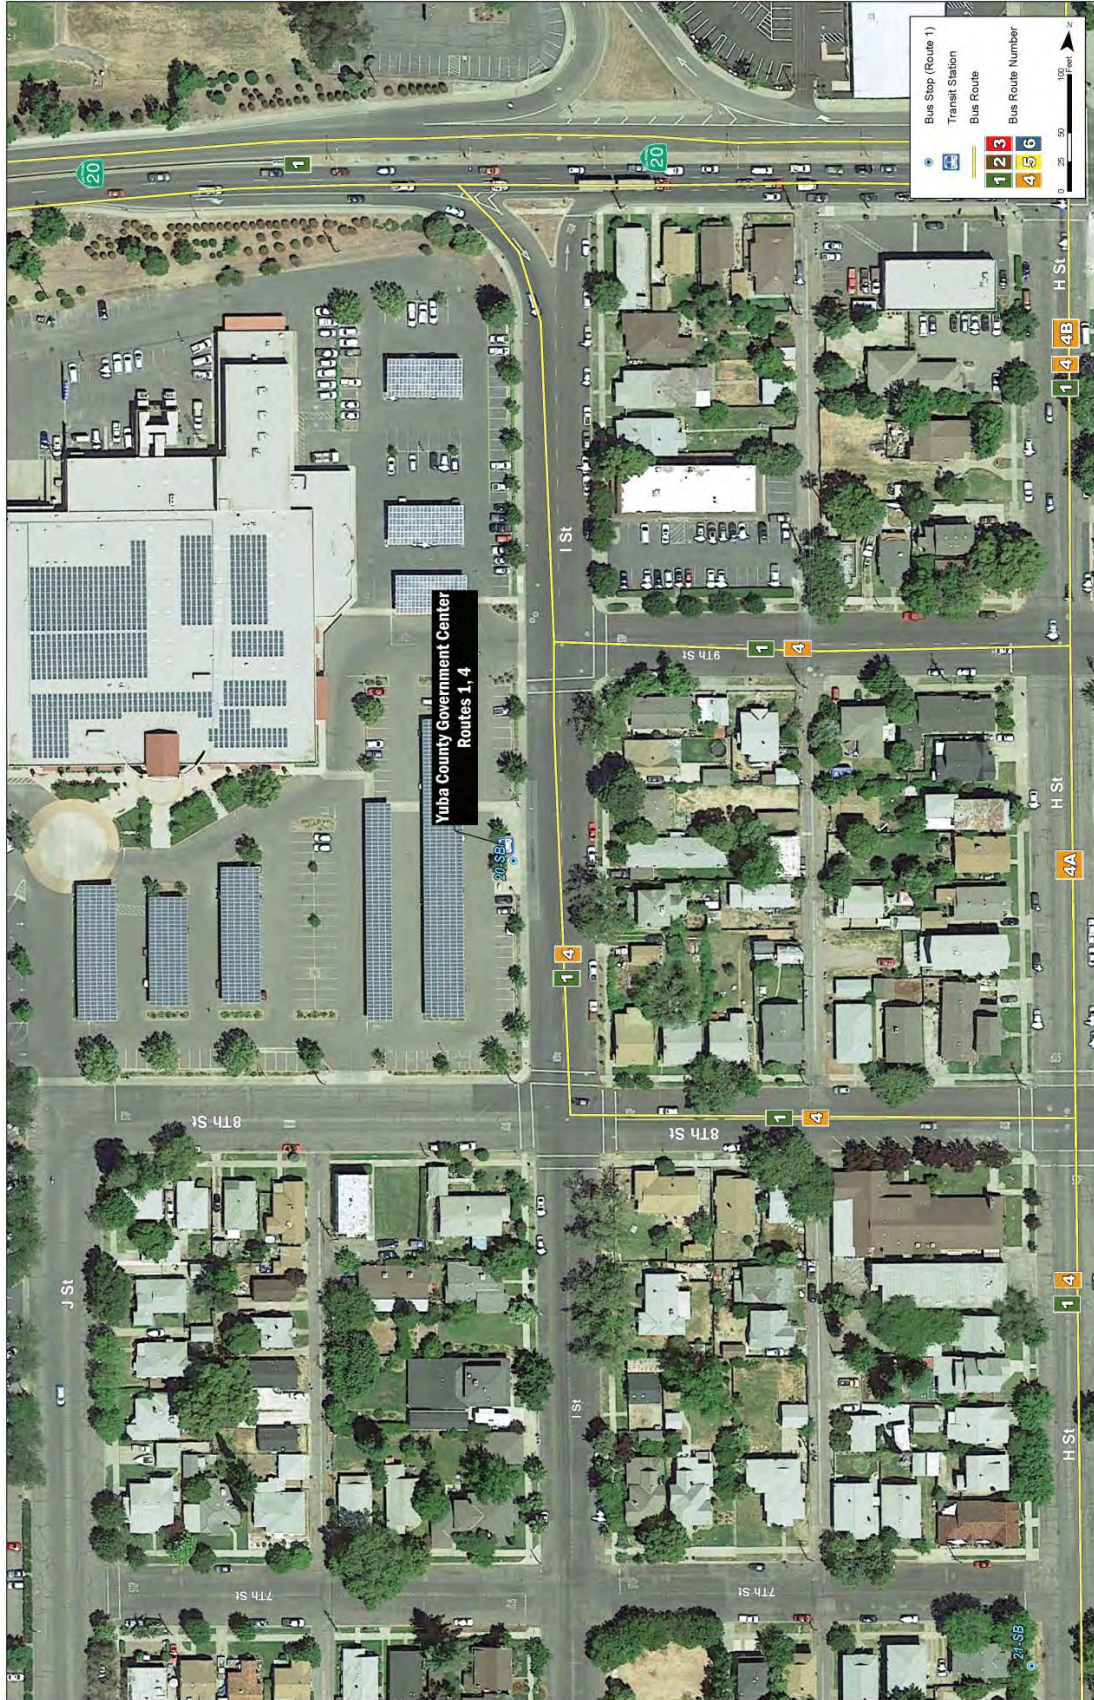
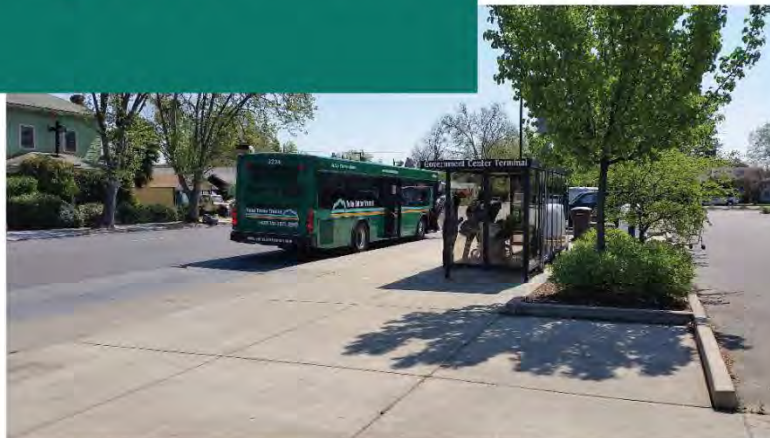
Figure 2.12: Yuba County Government Center Project Site

The Government center transfer terminal has an adequate amount of lighting despite the shelter lights not being operational. This is due to the bright parking lot lights located nearby. During the evening period, when low light conditions were observed, very little to no activity occurs at or near this transfer center.

The Government Center Terminal is located on the east side of the Yuba County Government Center on the west side of I Street.

- Narrow sidewalk adjacent to bus loading area
- Two protected pedestrian crossings across I Street

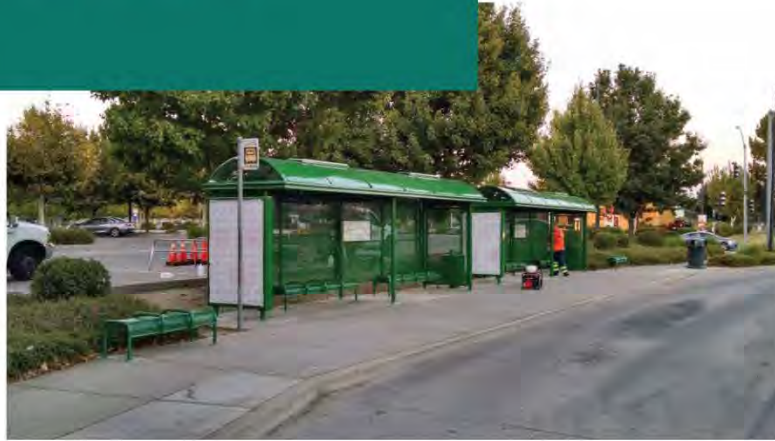
Figure 2.14: North Beale Transit Center Project Site

The North Beale Transit Center is actually two separate bus stops located on each side of the North Beale Road just north of the intersection with Lindhurst Avenue. The southern stop is located in front of a mall that is largely unoccupied, while the northern stop (see photo) is located along the Walmart parking lot.

- Protected pedestrian crossings across North Beale Road

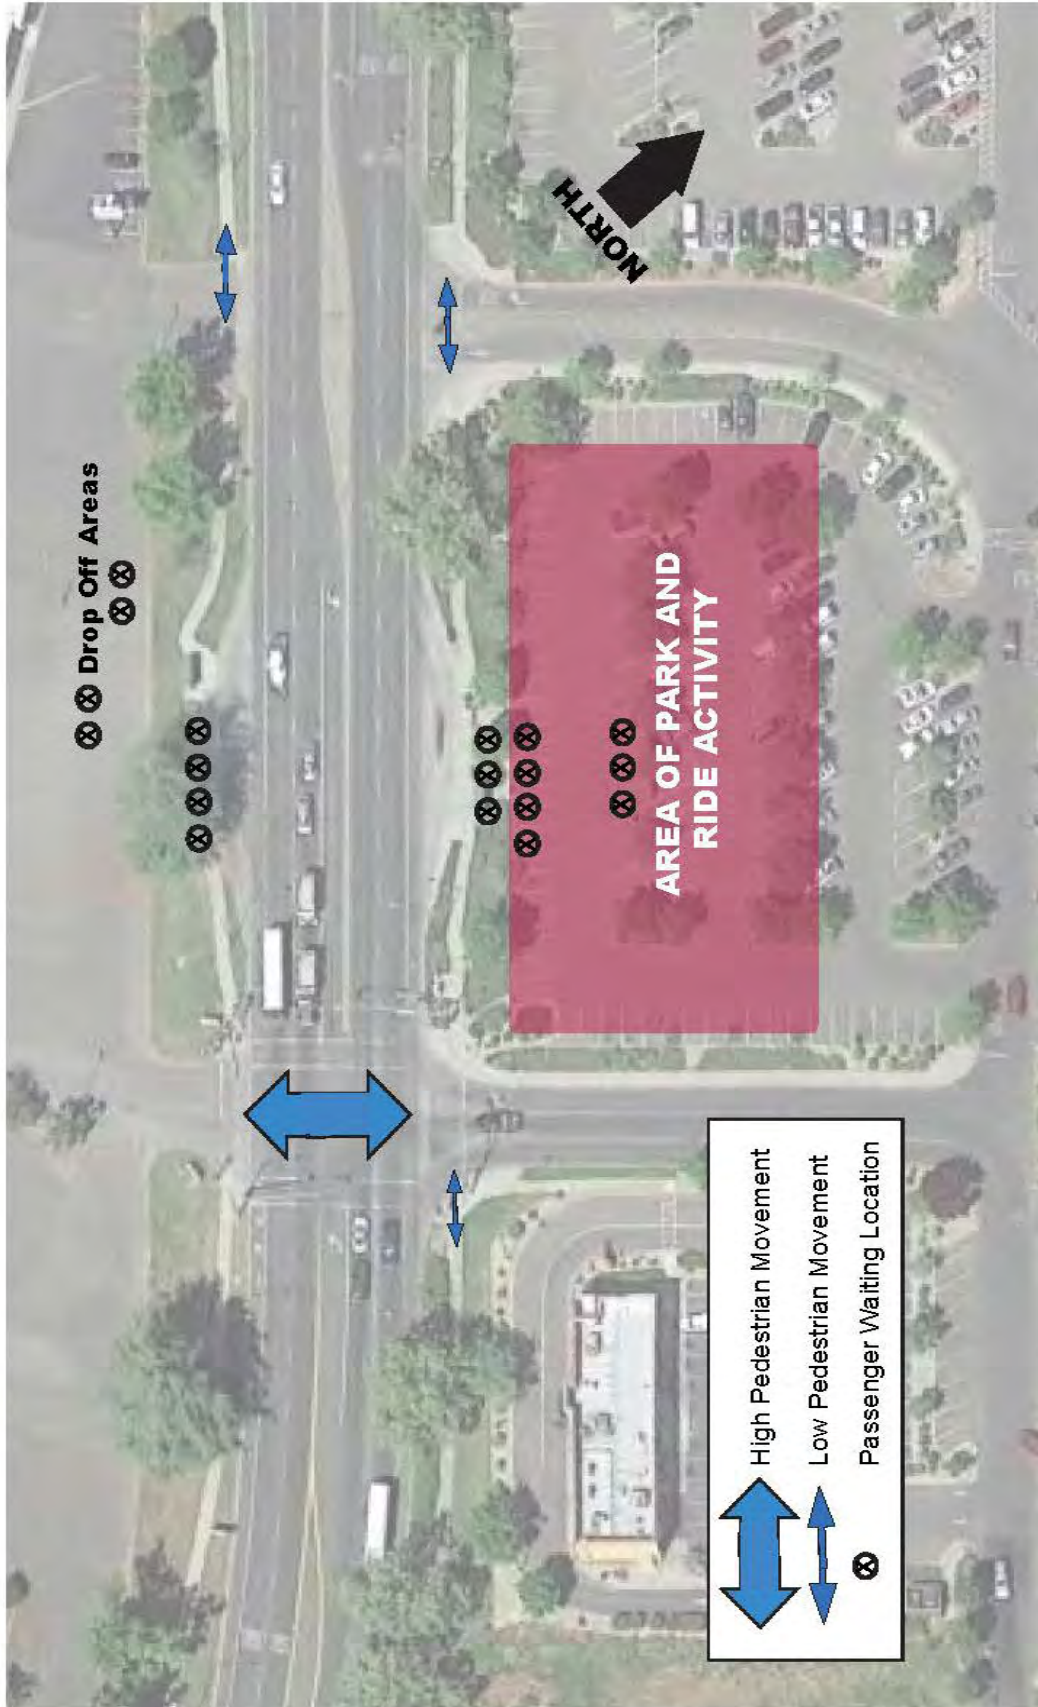
Figure 2.15: North Beale Transit Center Access

75% percent of those getting on and off at this location proceeded to the signalized intersection and crossed the street. No jaywalking was observed. Approximately 25% of those alighting waited at the terminal for transfers. Two separate riders were picked up within the abandoned mall parking lot. The abandoned mall parking lot was in use by vendors selling mobile phones and fruit (near the transit center). A mobile clinic (Class A motorhome) was also parked 25yards south of the terminal. Transit passengers waiting for the bus generally did so at the shelters or benches either within or just outside.

A large portion of those using this transit center (both sides) use the Walmart parking lot of the northern stop as a park and ride. Approximately 1/2 of the passengers were observed crossing North Beale Road and 25% of the transit riders using the northern stop had a car parked at the southern portion of the Walmart lot. Interestingly, no one was observed using the Feather River Center's parking lot as a park and ride lot (presumably for safety concerns). Approximately half of the passengers crossing North Beale and 25% of the passengers using the northern transfer stop were either visiting Walmart or the fast food restaurant on the corner. A small percentage of transit users walked (or rode bikes/skateboards) to the terminal along North Beale Road. The remainder of transit users were transfers.

Approximately half of the passengers waiting for the bus did so at the shelter/benches, the other half did so in the Walmart parking lot. A shopping cart return corral is located immediately north of the terminal. A number of passengers used the cross bars of the corral as seating or to lean against. Others would sit along the curb separating the parking lot and the landscaping. Some chose shopping carts to rest on.

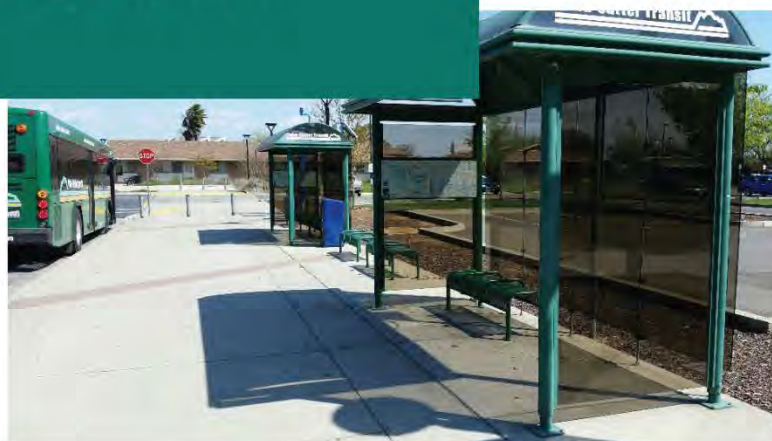
Figure 2.16: Yuba College Transit Center Project Site

A large garbage can with recycling is provided. Two street lamps are present at the stop location along with an emergency call button. The transit stop is located just south of a grassy park like area and west of the campus police station. It was observed that the bus drivers commonly use this stop to take breaks and leave the buses (bus empty, door locked). One car was observed using the bus lane to cut through to the eastern portion of campus.

The low level shelter lights are very dim. The two additional street lights at the bus stop provide sufficient lighting for the transit center. The surrounding areas of the campus are well lit. There is very little activity at this stop at night. Do to the lighting, nearby campus police, and the emergency call box, the transit stop feels safe.

The Yuba College Transit Center is located off of North Beale Road within the college campus.

- A transit-only lane allows the buses to reach the terminal with no conflicts with public vehicle traffic adjacent to the stop
- Protected pedestrian crossing across the transit-only lane
